In Situ Observations on the Crack Morphology in the Ancient Timber Beams

Nicola Ruggieri

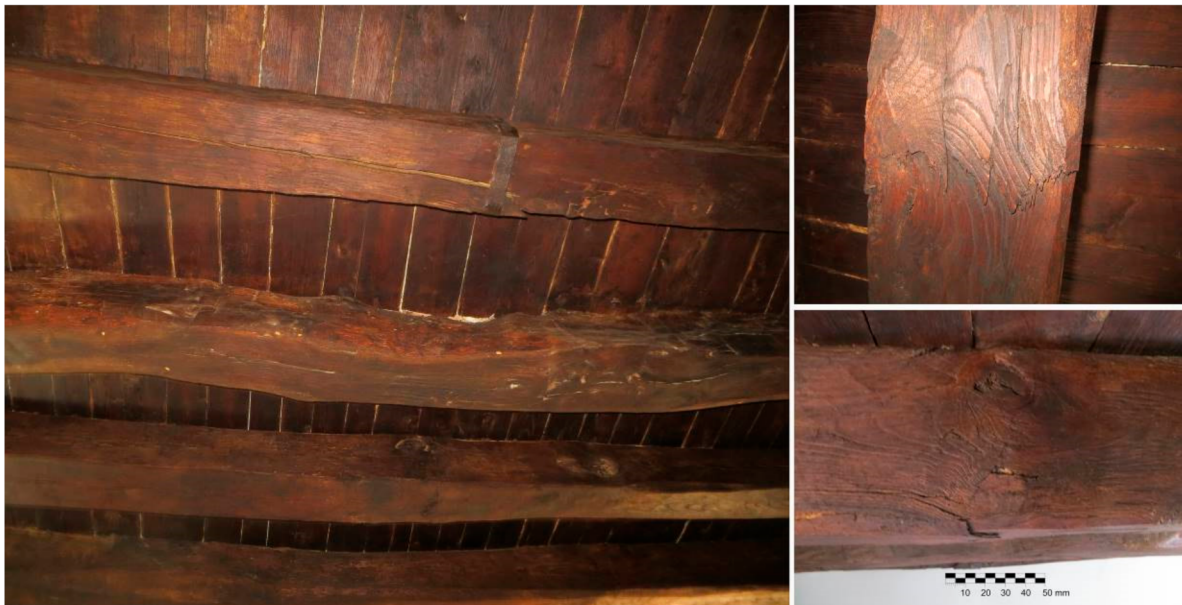
Figure 1. On the left: Timber floor of a room contiguous to the cloister of Saint Daniel's convent (Belvedere, South Italy). The beam in the foreground highlights fiber delamination facilitated by the shrinkage check and by the deviation of the grain. On the right above: The superficial crack at the lower edge of a beam of the Saint Daniel's convent triggered by a knot as well as by the local grain deviation. On the right below: The superficial crack has affected the face of a beam of the Saint Daniel's convent triggered by a knot as well as by the local grain deviation.

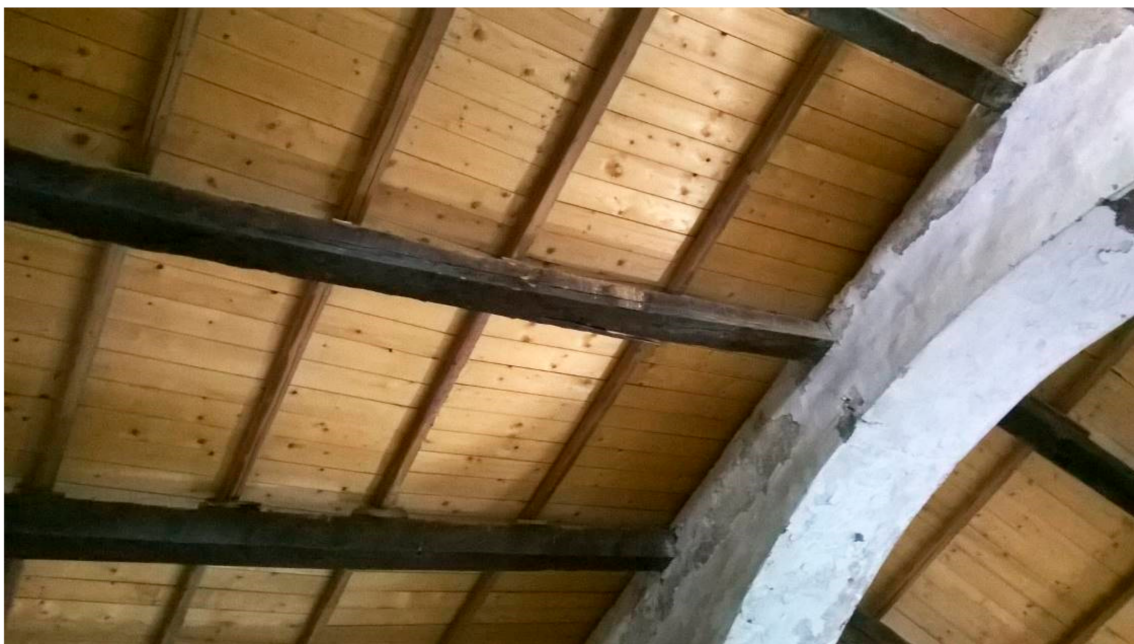
Figure 2. Cosenza (Italy), fiber delamination in a beam of the early 20th century.

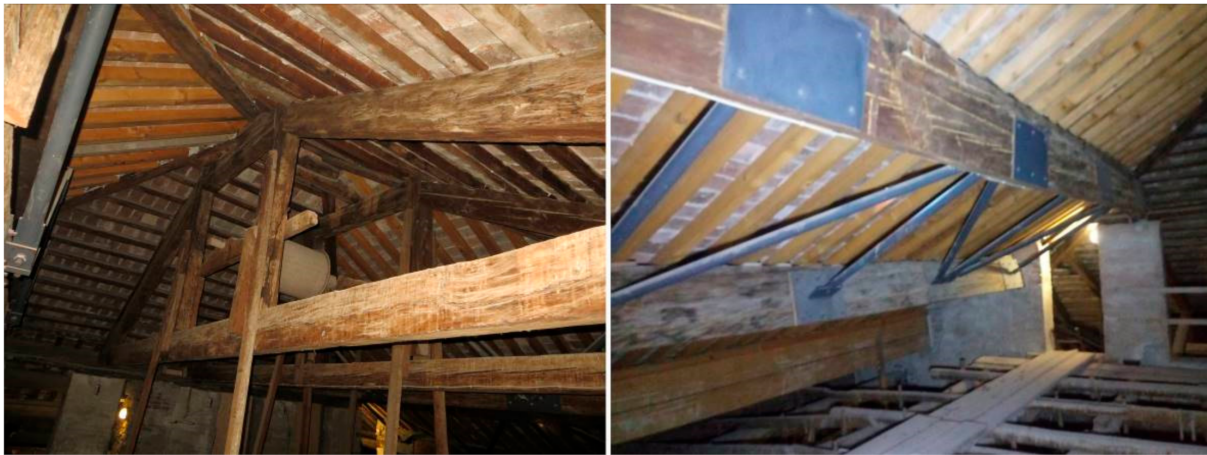
Figure 3. On the left: The two trusses of the roof carpentry of Palazzo Tassoni Estense in Ferrara. On the right: The structural units at the two lateral ends.

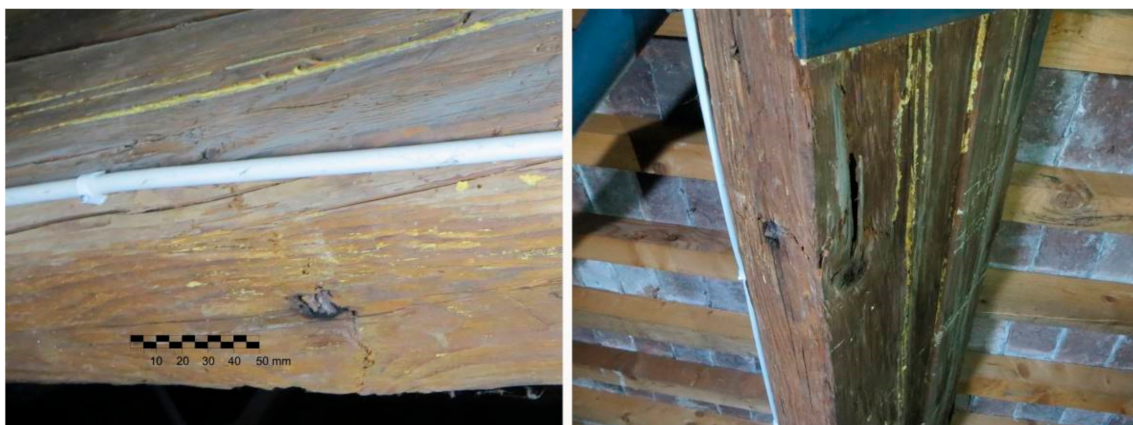
Figure 4. Roof carpentry of Palazzo Tassoni Estense in Ferrara. On the left: The crack was propitiated by the presence of a hole. On the right: The crack assumes a trend following the knot perimeter on the beam face.

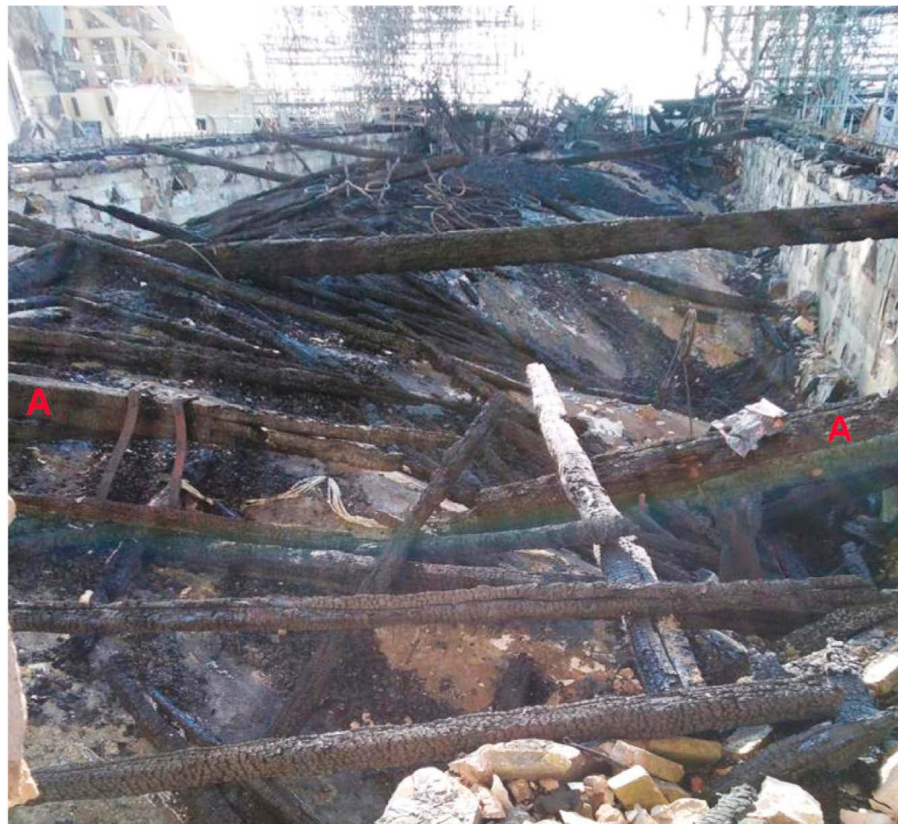
Figure 5. The beam (approximately in the middle of the photo with two iron strips, indicating by the letter “A”), belonging to the structural system of the roof of Notre Dame’s in Paris, was broken in two parts after the fire of the 15 April 2019.

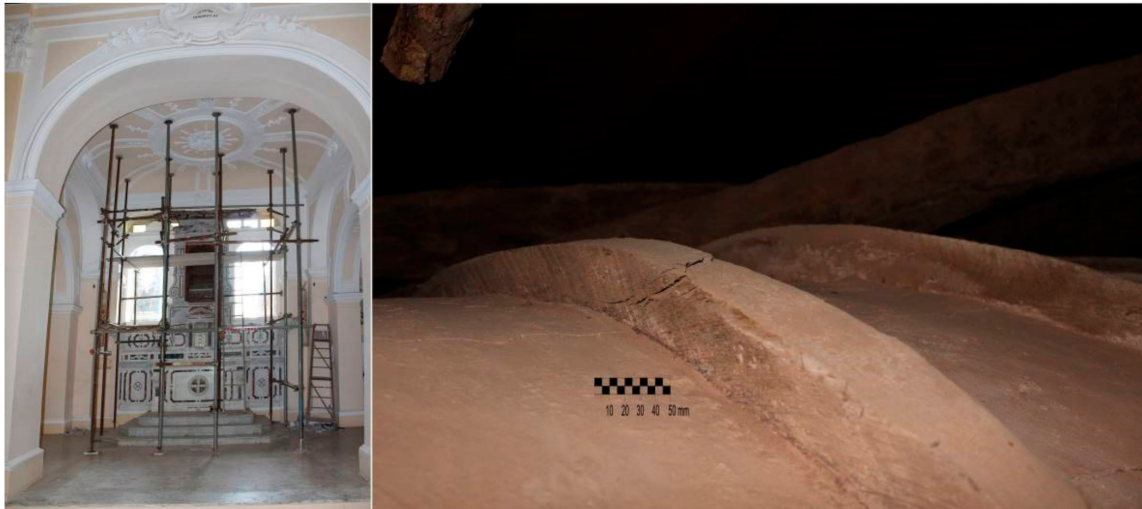
Figure 6. On the left: The intrados of the Santa Maria della Grotta's vault (Praia a Mare, South Italy). On the right: The negative bending moment in the rib, near the springer, has generated cracks parallel to the grain.

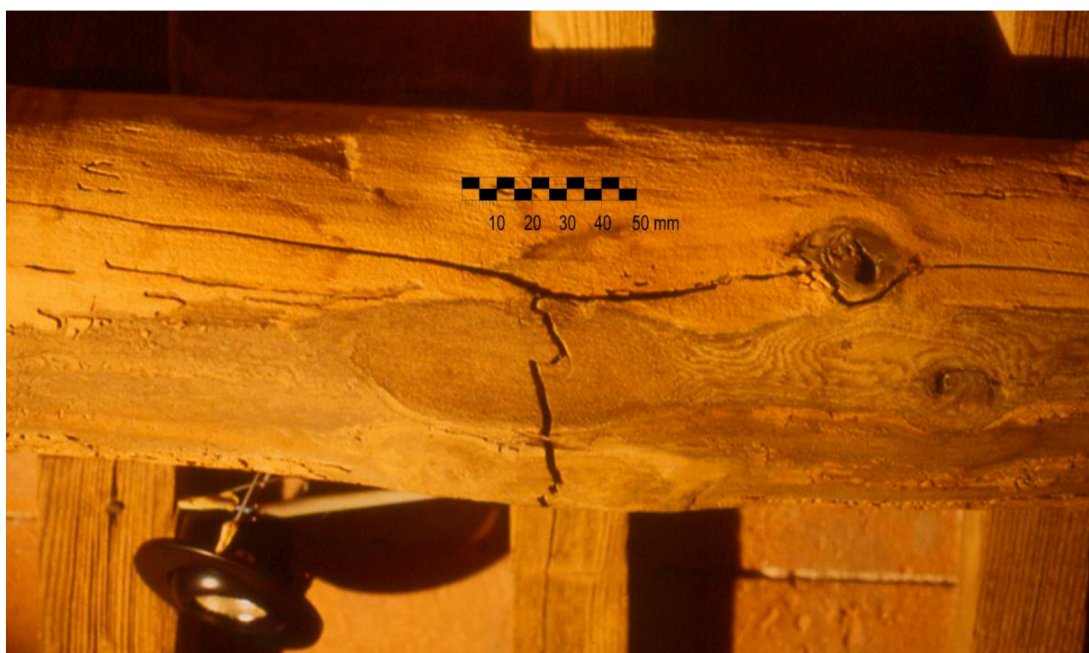
Figure 7. Failure due to wood internal anomalies in a beam of a house in Pietrasanta (Italy) (Photo Tampone G.).

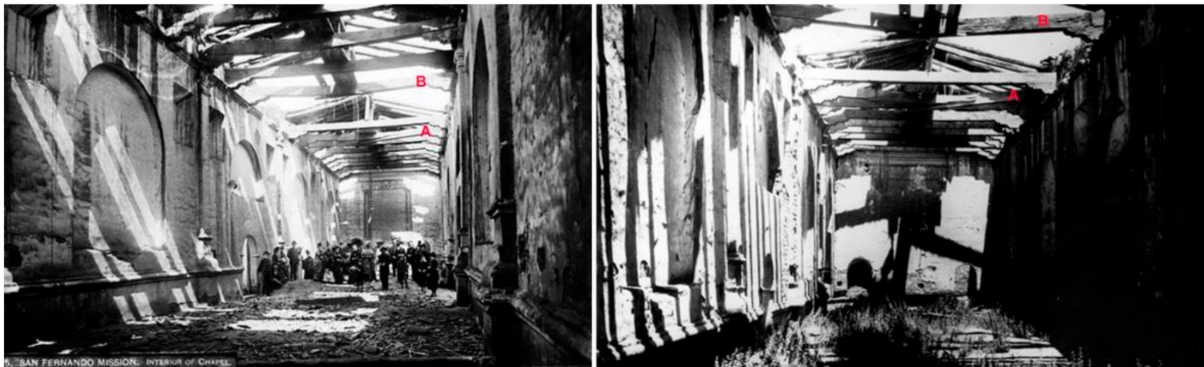
Figure 8. On the left: Photograph of the 19th century depicting the roof carpentry of the church of the San Fernando Rey de España in California struck by the 1812 earthquake. On the right: Early 20th century photograph of the church of the San Fernando Rey de España taken after those of the photo on the left (note the weed vegetation). The splitting between the fibers increased due to creep phenomena, favored by the exposure to high values of humidity, as well as to possible weakening of the resistant section caused by biodeterioration.

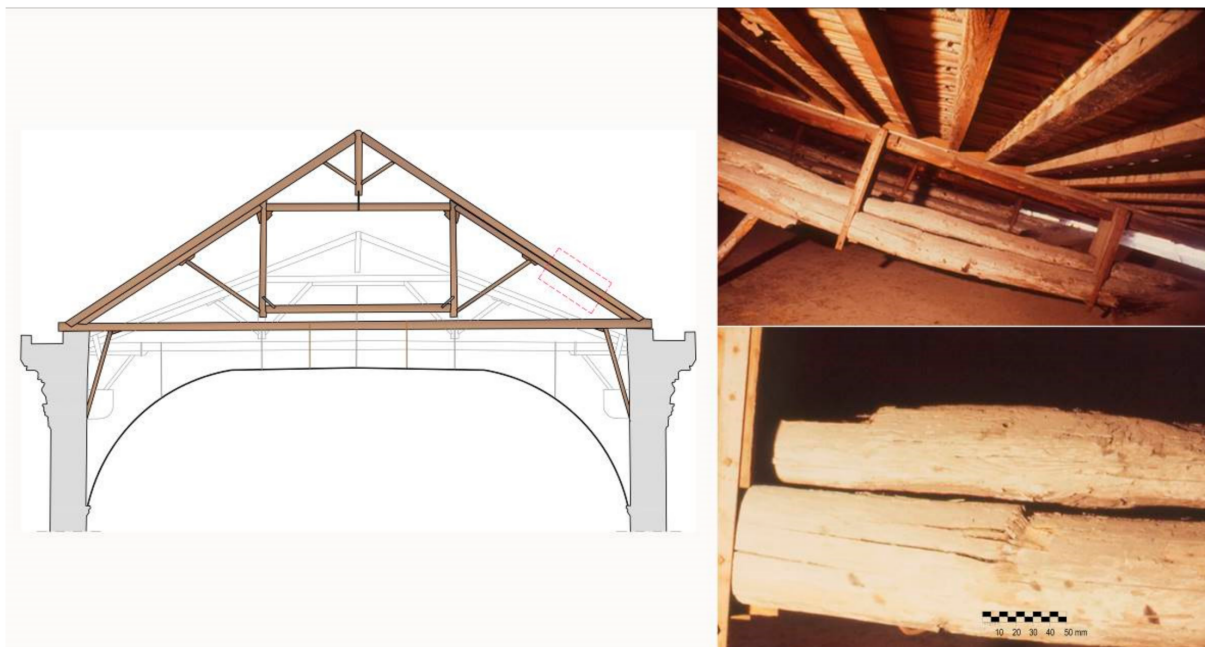
Figure 9. On the left: Roof load-bearing structure of the Royal Palace in Naples. There are two typologies of trusses. On the right above: Rafter and under-rafter of one of the Royal Palace trusses. The lower member is considerably deformed and shows the crushing-splitting fibers (Photo Tampone G.). On the right below: Roof trusses of the Royal Palace in Naples. Nonlinear behavior of the under-rafter with crushing-splitting of the fibers at the upper edge of the member (Photo Tampone G.).

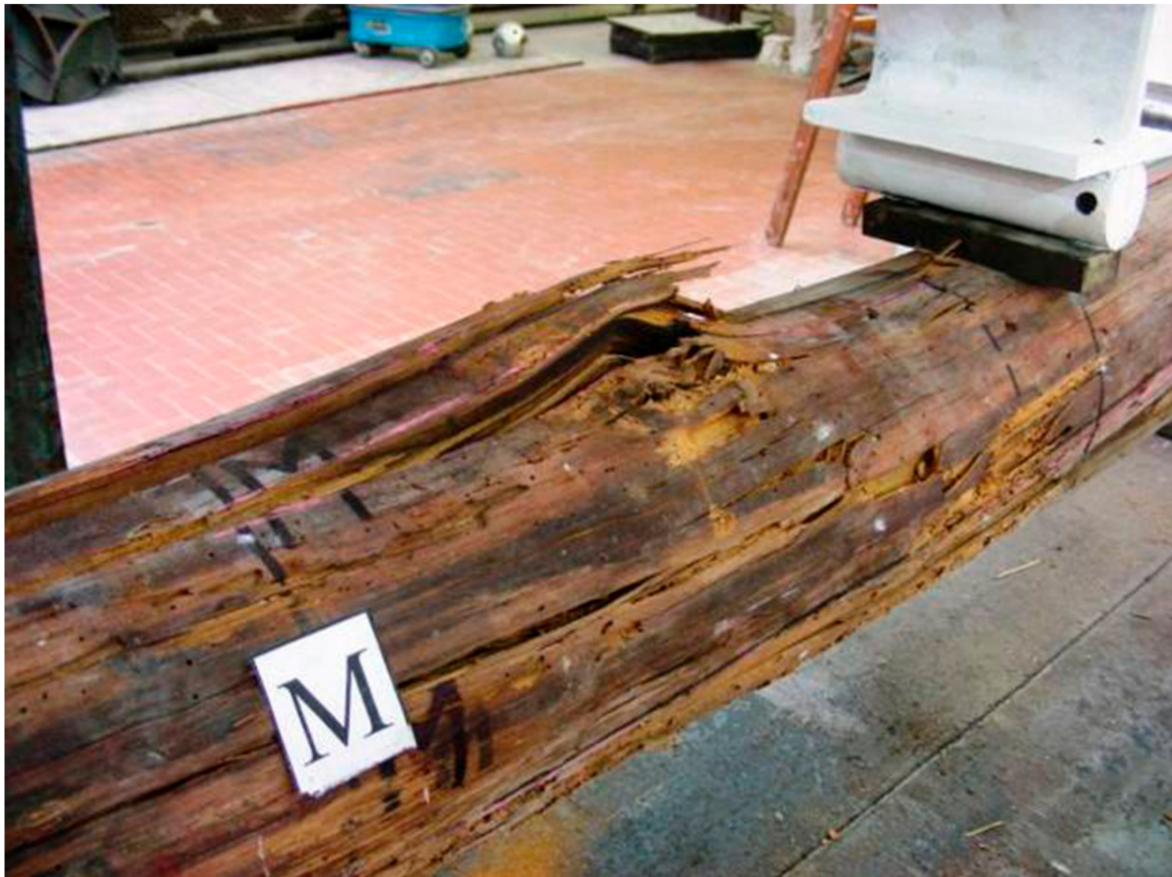
Figure 10. The tested beam shows the plasticization of the compressed fibers at the upper edge (Photo Faggiano B.).

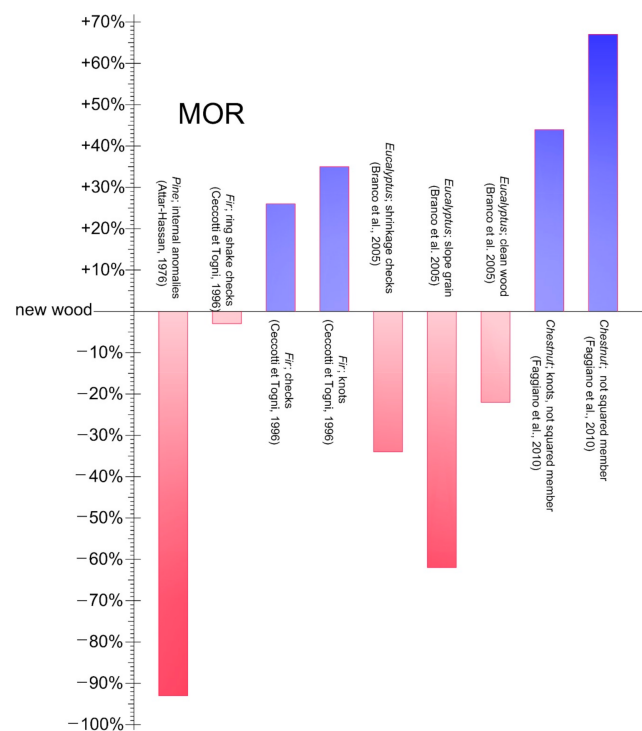
Scheme 1. Correlation between MOR values of aged and new timbers, from the literature review. Positive/negative values indicate higher/lower MOR than that of new timber. Source of new timber strength properties: chestnut, MOR 28 MPa; silver fir (category II), MOR 28 MPa (from “UNI, Ente Nazionale Italiano di Unificazione, 2009. Structural timber. Strength classes UNI EN 338:2009, Milano, Italy”); eucalyptus, MOR 127.5 MPa (from “LNEC–M6, 1997, Eucalipto comum., Fichas Técnicas, LNEC, Lisboa”); eastern white pine, MOR 34 MPa (from “Green, D. W. Winandy, J. E., Kretschmann, D. E. 1999, Mechanical properties of wood. Wood handbook: wood as an engineering material. Madison, WI: USDA Forest Service, Forest Products Laboratory. General technical report FPL”).

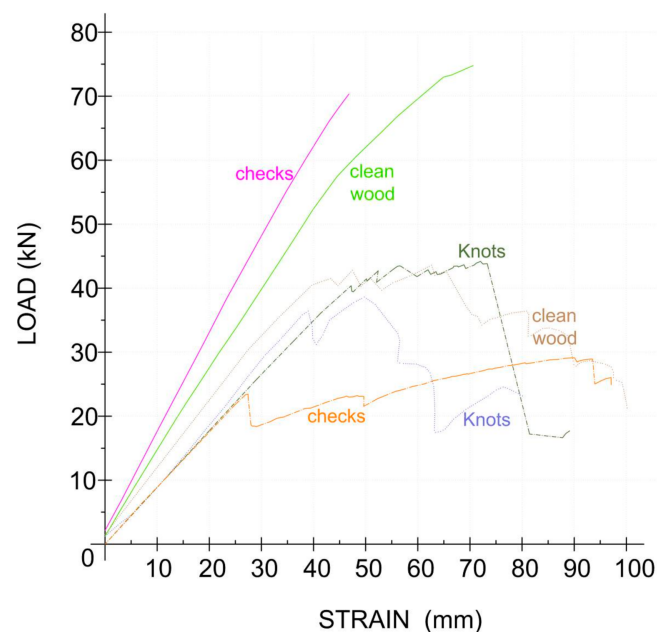
Conversely, the beam salvaged from a factory built in 1914 in S. Joao de Madeira, made of *Eucalyptus globulus labill.* wood [4] and characterized by deep checks that reach the heart of the tree, has showed a linear-elastic behavior with a brittle rupture immediately after reaching the F_{max} value. The eucalyptus specimen graded as clean wood has exhibited the classical bending failure [4] with the plasticization of the compressed side and the successive crack generation at the lower edge of the beam. However, it has highlighted low ductility, if compared to the tested chestnut and silver fir beams.
