Assessment of the Impact of Human Activities along the River Ngadda Channel, Maiduguri, Borno State, Nigeria

Original Research Article

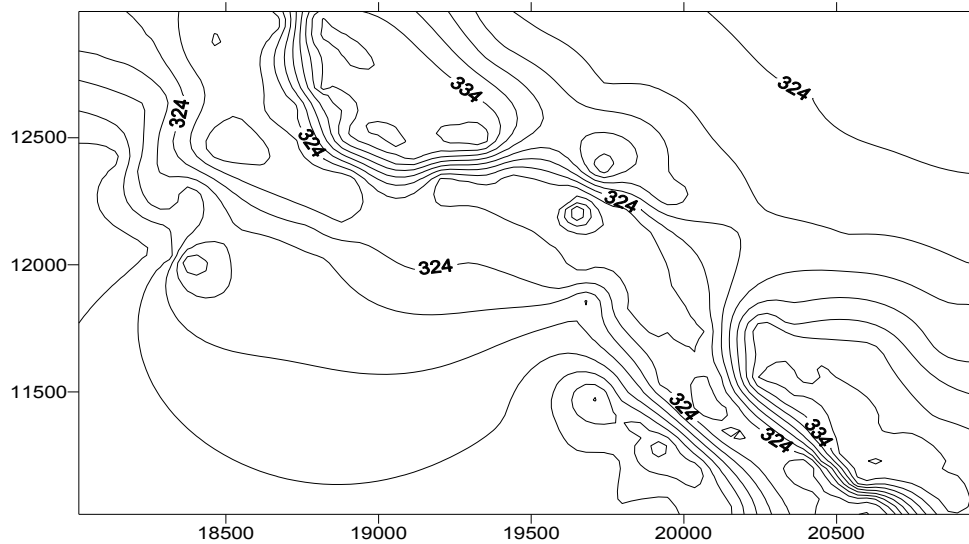
Fig. 2. Landforms of the study area
 Source: Fieldwork; April 2014; Scale: 1:2500

Fieldwork results revealed that River Ngadda is generally characterized by a relatively flat terrain as shown on Fig. 2. On the eastern bank it is 324 m asl by the edge of the bank and increases to about 336 m asl away from the bank. Results of some slope measurements carried out in 20 locations are as shown in Table 1. It can be seen from Table 2 that five of the plots have very steep slopes which made the areas liable to splash, sheet, rill and gully erosions.

On the western bank the relief height is 321 m asl at the edge of the bank and increases to about 336 m asl away from the bank as shown on Fig. 2. This finding disagree with similar work carried out by [9] on the assessment of gully erosion in Gombe Town.

terrain. On the eastern bank it is 324 m asl at the edge of the bank and increases to about 336 m asl away from the bank. The western bank has a height of 321 m asl at the edge of the bank and increases to about 336 m asl away from the bank. Human activities along the channel include settlement, farming, fishing, quarrying, mining, excavation, grazing and deforestation. Result of some slope measurement carried out in twenty locations as shown in Table 2, revealed that five of the plots have very steep slopes which made the areas liable to splash, sheet, rill and gully erosions. The study found out that some people are aware of the hazards associated with human activities along river channel but choose to engage in them because they have no other alternative while others are not aware of the implications of their actions.

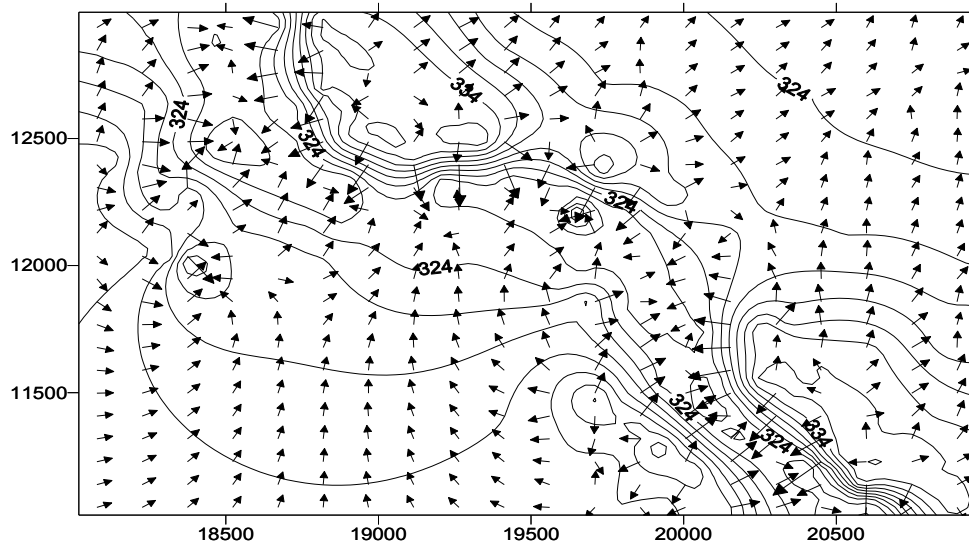
Fig. 3. Vector map showing the terrain and direction of flow of water
 Source: Fieldwork; April 2014; Scale: 1:2500

The nature of the Landforms as revealed by the Vector map in Fig. 3 shows how the relief determines the direction of flow of water in the River Ngadda Channel. This result disagree with similar work done by [10] on Terrain analysis of Biu plateau, for road transport development, Borno State.

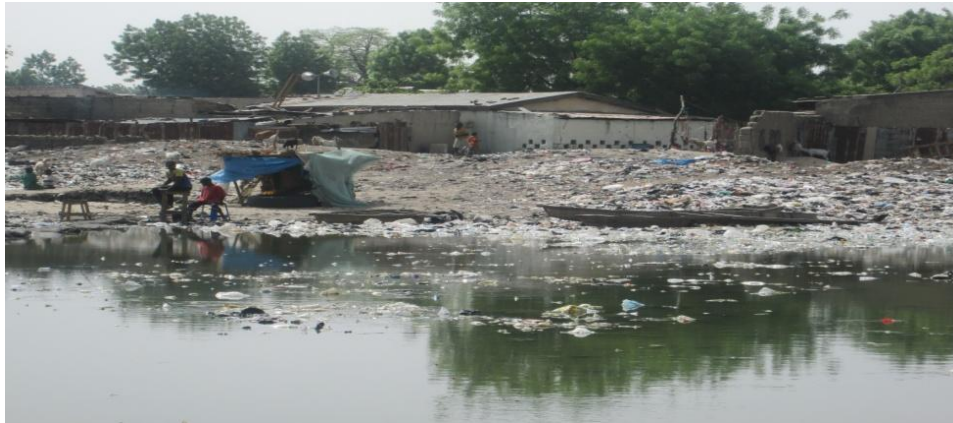
Plate 1. Settlements along river Ngadda channel

Field observation revealed that settlements are one of the socio-economic activities carried out along the Ngadda channel. The settlements are linear in pattern as they reflect the morphology of the channel as shown in Plate 1. The nature of the topography provides easy accessibility for both man and animals in and out of the settlement. It was observed that the foot paths, roads, animal tracks originating from the settlements provide the points from which gullies develop. The continuous trampling of the soil by both man and animals initiate rill erosion that subsequently developed into gullying.

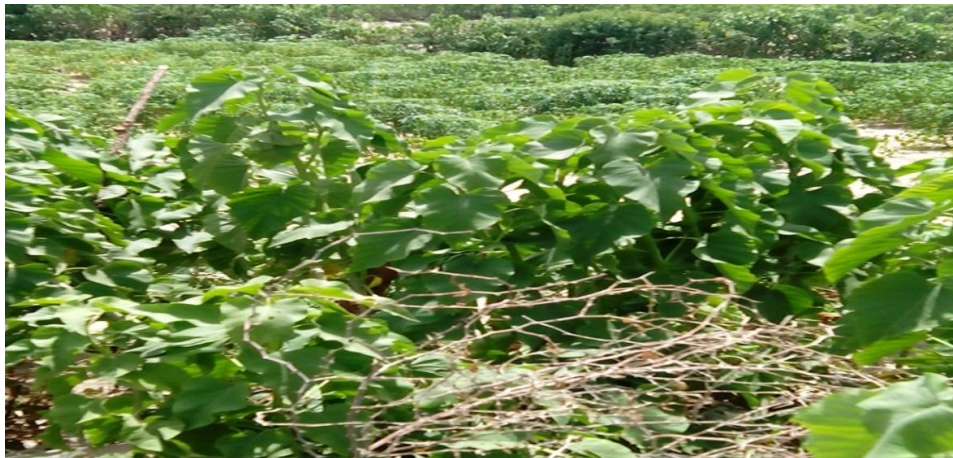
Plate 2. Shows irrigation farming for subsistence consumption

Source: Fieldwork, July 2014; N11° 48' 203"; E13° 10'39.7"; Elevation 1072 ft

The respondents pointed out that soil in the Ngadda floodplain and riparian environment is very fertile and crop can do well and yields can be substantially high (see Plate 2) where soil creep and landslides do not destroy their farmlands.

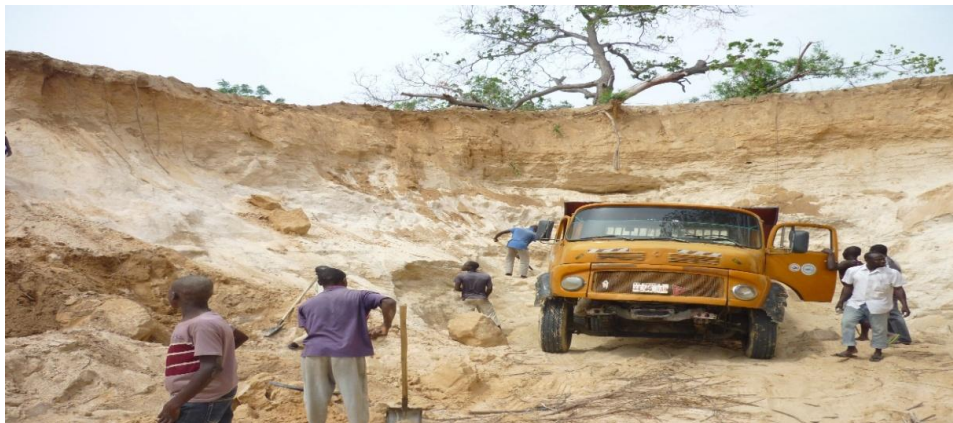
Plate 3. Showing quarrying activities around the river channel

The study revealed that these activities cause accelerated gully erosion that eventually leads to soil creep and landslide and silting or sedimentation of the river channel. Some measurements of the width of the channel carried out at fifteen different locations are shown in Table 4. The measurements revealed that the channel of the river Ngadda is under serious threats of contraction at some points with width of 65 m at Point 15 and expansion with width of 140 m at Point 1. This could be attributed to the activities in the channel environment as shown in

Plate 3. This finding agrees with that of a similar study by Kagu [6] that human activities in and along the River Ngadda channel had affected both the depth and width of the river.

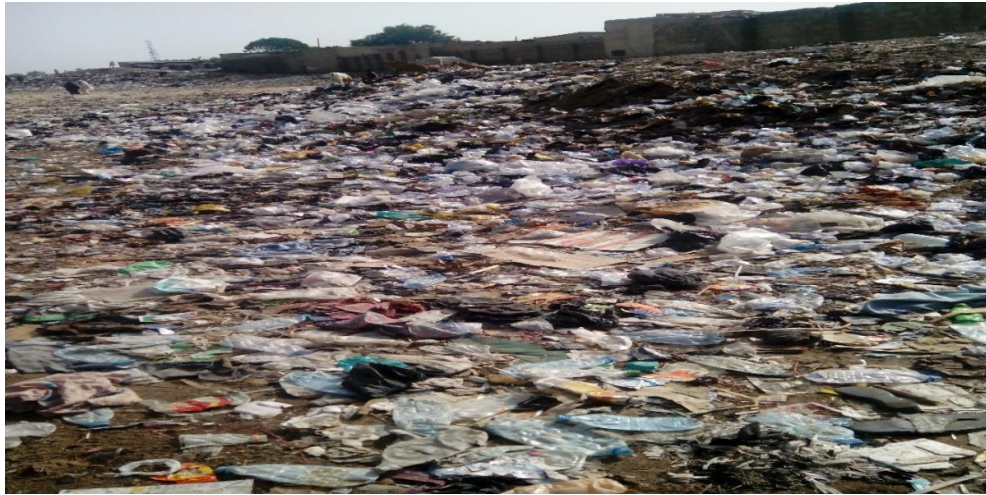
Plate 4. Refuse dumping site in the river bank

It was observed in the area during fieldwork that indiscriminate dumping of refuse in and around the channel of the River Ngadda poses a great threat to the free flow of water as shown in Plate 4.

The residents in the area revealed during interview that they are aware of the implications of their actions but were left without an alternative. According to them they do not have any other place meant for refuse disposal. However, it was observed that this was only an excuse as there are designated places to dump refuse, which the respondents do not want to use because of distance. They revealed that the river has the ability to transport these refuse downstream during the raining season as such it will not result to floods "as refuse has no power of blocking the water from flowing." However, they further revealed that they are not aware of the implication of the water pollution aspect and that river has a natural way of purifying itself.

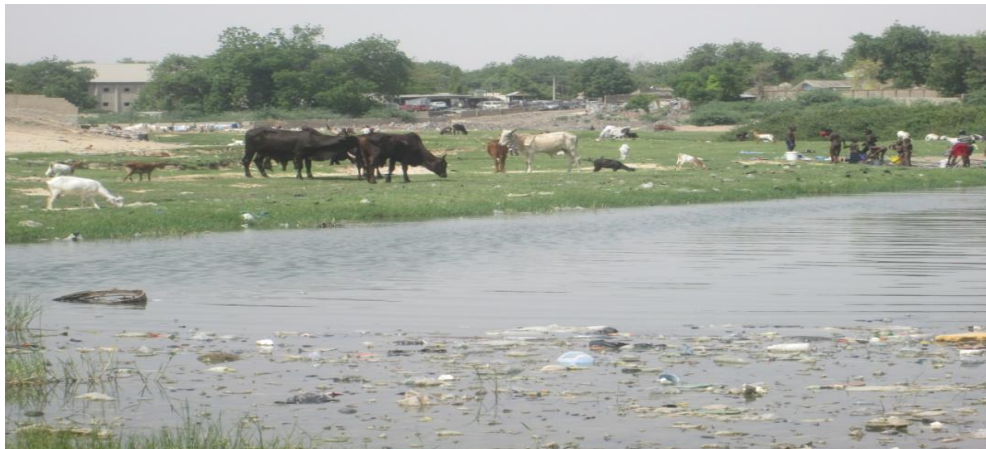
Plate 5. Cattle grazing on the floor of river Ngadda

Grazing on the floor of the River Ngadda channel was also observed during the fieldwork as shown in Plate 5. According to the people the floor of the river provides the best pasture for their animals especially during the dry season when pasture is scarce. The continuous grazing and trampling of the floor of the river by the cattle expose the soil.

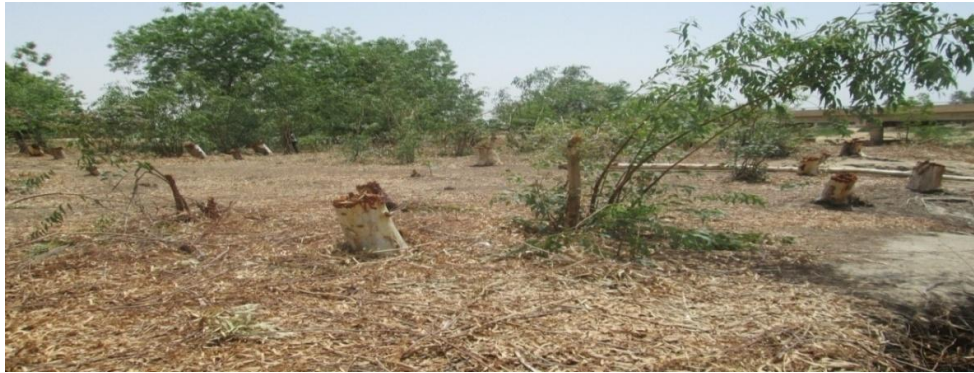
Plate 6. Deforestation on the bank of river Ngadda
Source: Fieldwork; March 2014

Indiscriminate felling of trees occurs along the channel of River Ngadda as shown in Plate 6.

This and other activities in the riverine environment have significantly enhanced geomorphic processes such as splash, sheet, rill and gully which are operating in the area and are capable of posing a serious threat to the river and its environs if not already so.

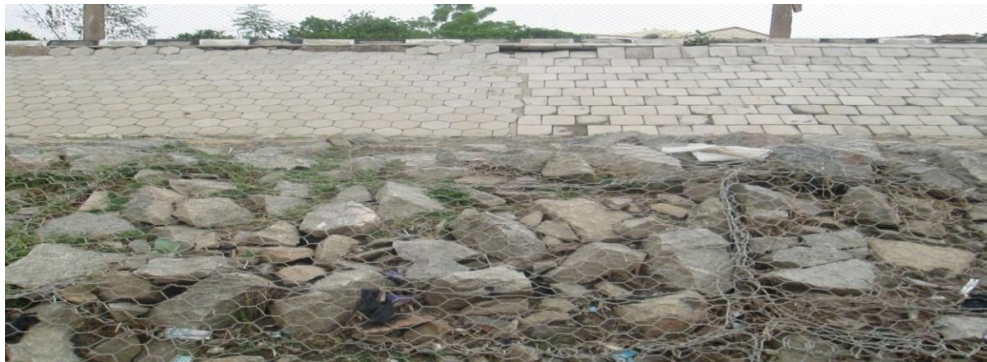
Plate 7. Embankment at water treatment plant
Source: Fieldwork; March 2014

The finding revealed that 60% of the respondents are expecting flood once it is rainy session, 30% are contemplating its occurrence while 10% believe that the government has done more than enough to prevent flood from occurring as shown by the embankment at the back of the Maiduguri Mother Cat water treatment plant as shown in Plate 7.
