Anthropogenic Geomorphology of the Magoye Riverine Landscape, Zambia

Original Research Article

Keywords: Anthropogenic Geomorphology; buffer zone; channel morphology; Magoye River.

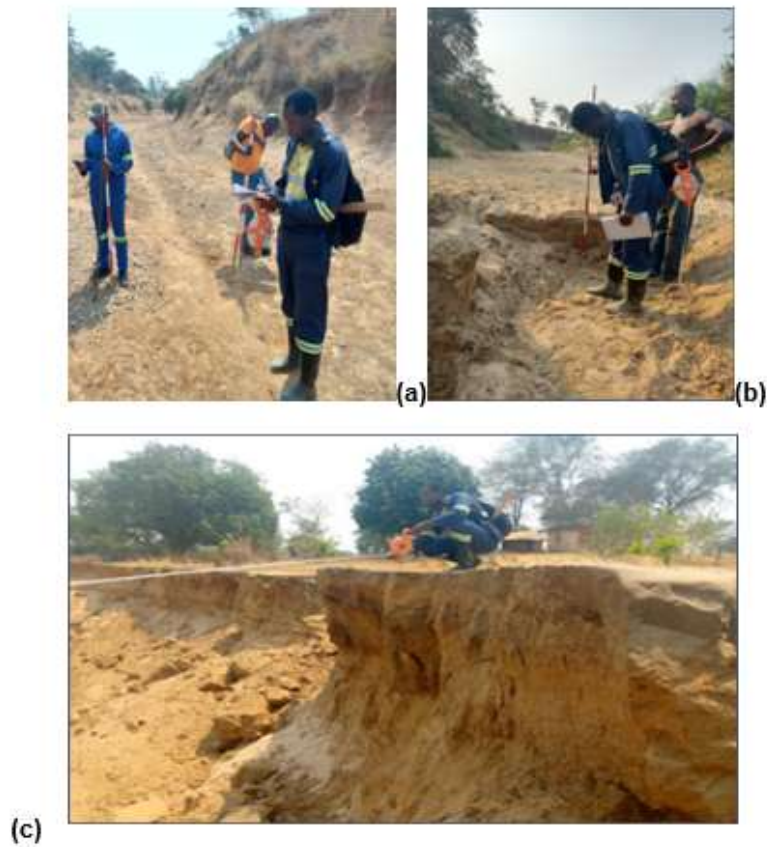
Fig. 2. (a-b) Field measurements of sediment depth and (c) Degraded channel and bed morphology of the Magoye River

observation guides with the aid of handheld GPS. Each section was measured for initial channel width and current channel width simultaneously. In selected sections, the initial river channel widths were detected using remote sensing from Google Earth. The total number of assessed sections of the channel width were 31. Below is Fig. 2. (a)-(b)-(c) that show data collection on the channel and bed morphology of the Magoye River.

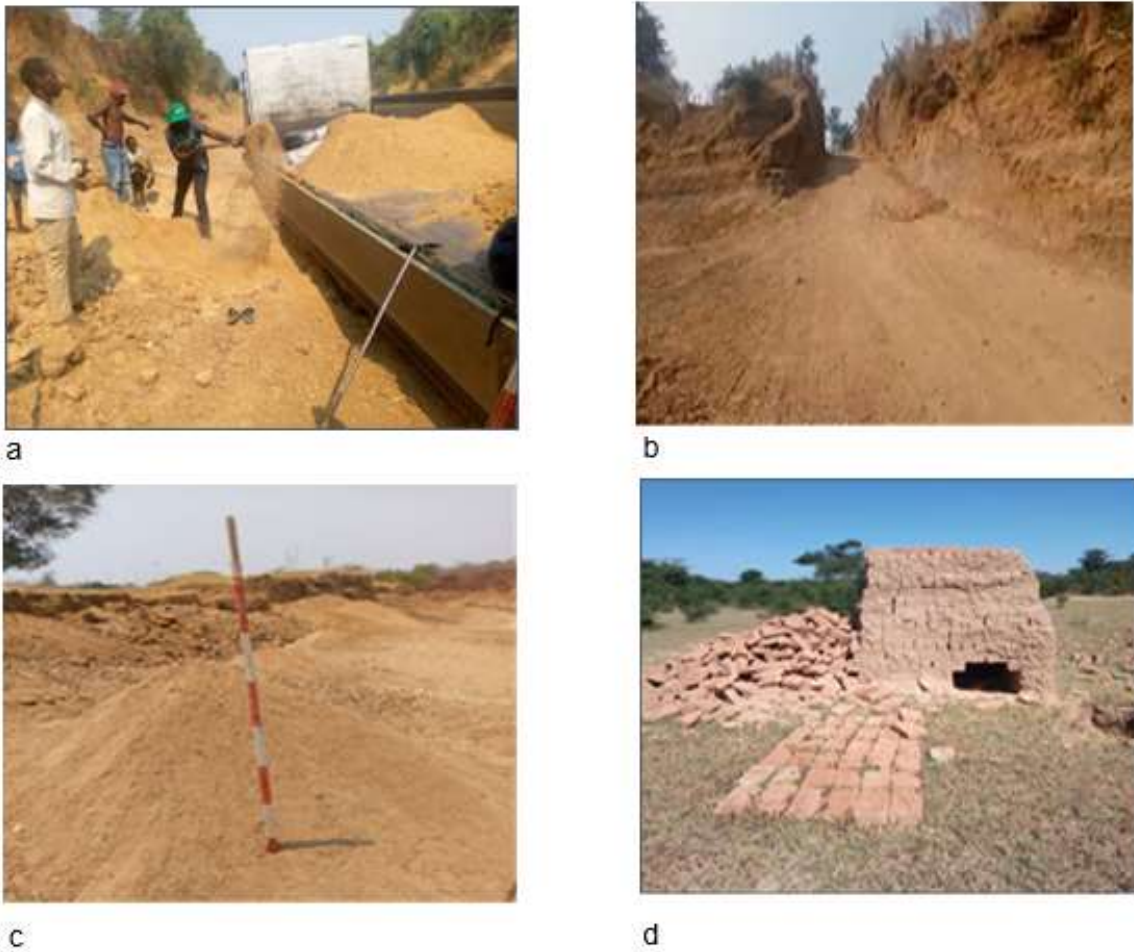
Fig. 5. Showing (a) Sand collection (b) Vehicle access roads (c) Sand cone (d) Brick moulding

The findings further reveal that, the most imposing was excessive siltation of the river channel bed leading to drastic loss of flowing water-holding capacity, potential oxbow lakes and floodplains formation. This coupled with sand mining triggered heavy burden of sediment on the riverbed amounting to over 5 million cubic Meters spread across 460, 000m² of dry surface area. Through field experimental assessment on 31 out of 47 damaged cross sections of the river channel widths from the Magoye River, the study noted other geomorphic features like water access points, sand collection, vehicle access roads, sand cone and brick moulding (Fig. 5).

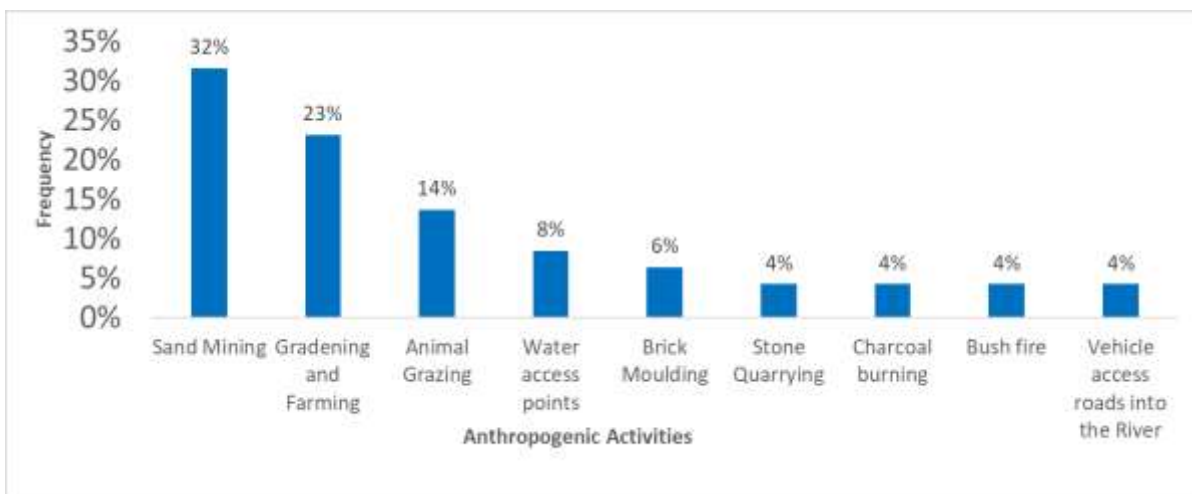
Fig. 6. Frequency of occurrence of anthropogenic activities within the buffer zone, downstream of the river channel

This enhanced sediment inflows into the river especially during rainy season eventually disturbing the stability of the riverbanks. The frequency of occurrence of anthropogenic activities within the buffer zone of Magoye River channel on the downstream as shown in Fig. 6.

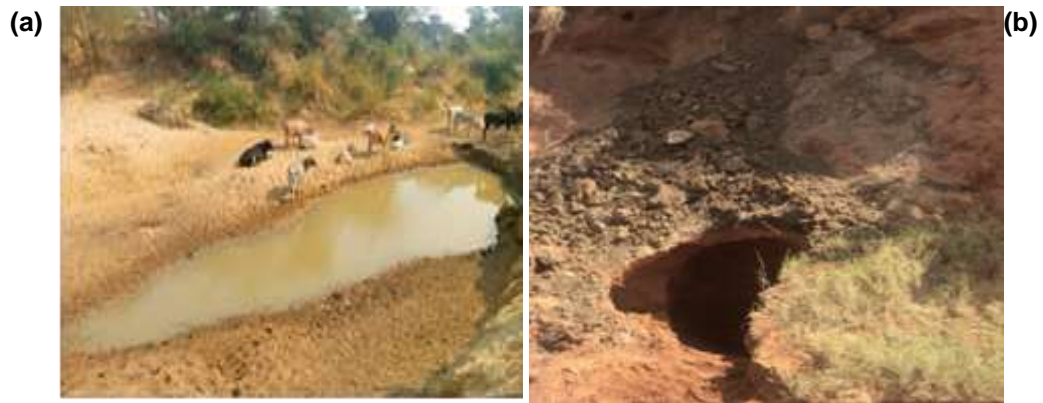
Fig. 7. One of the water pools (a) on Riverbed and a Riverbank cave (b)

The visual evidence of some of the observed destructive human activities in the buffer zone are qualified in Fig. 8, which depicts negative impact of stone quarrying on the river bed and microphytes and micro invertible organisms, river bank cutting to create road access into the river, brick moulding and sand mining. Fig. 7 (a) Reservoir on the riverbed (b) Sand open-pit.
