Suspended Marine Litter in Akwa Ibom State, Nigeria: A Case Study of Cross River, QUA Iboe River and Jaja Creek

Original Research Article

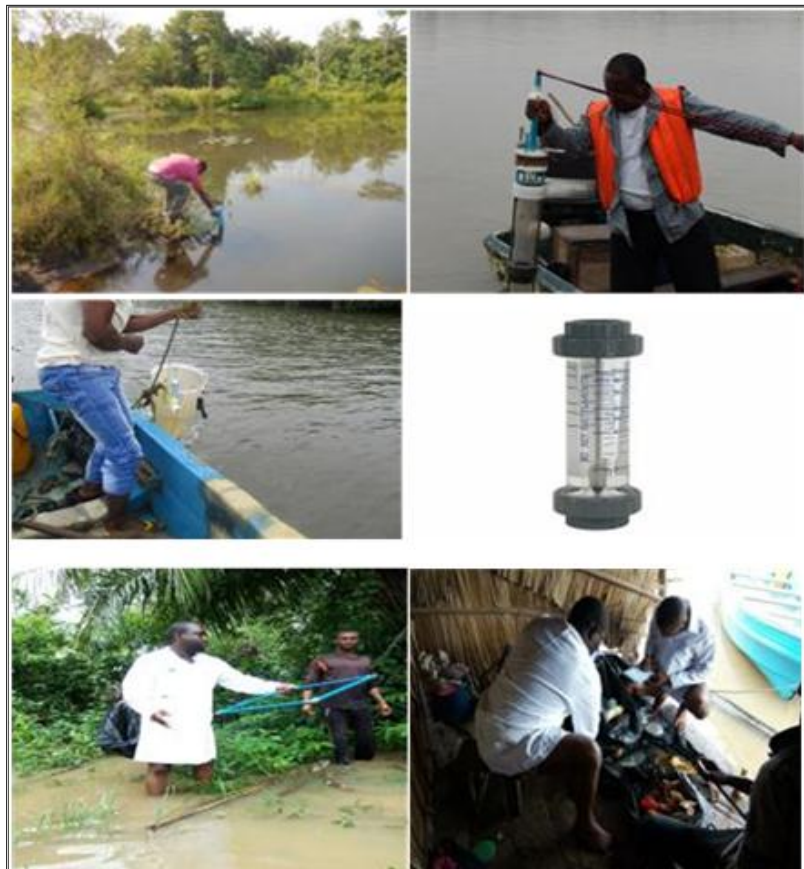
Plate 3. Instrument used during field survey

The depth of the rivers was measured using a type H1-ITL depth resounding water gun (Plate 3) and supported with a gravity corer (Plate 3).

Andrea recording current meter (RCM 9) with Acoustic Doppler current sensor 3620 was used in water current measurements (Plate 3). The current meter is self-recording and intended to be moored to measure and record the vector-averaged velocity and direction of the tidal current. The instrument features a newly developed RCM Doppler current sensor.

A quadrat technique was used to assess the amount of material. Quadrat sizes of 50 cm² and 1 m² (Plate 3) were deployed at random

Material collected from the quadrat are spread on a 1meter nylon and sorted out into its constituents according to ASTM D5231 – 92 [7] standard procedure (Plate 3).

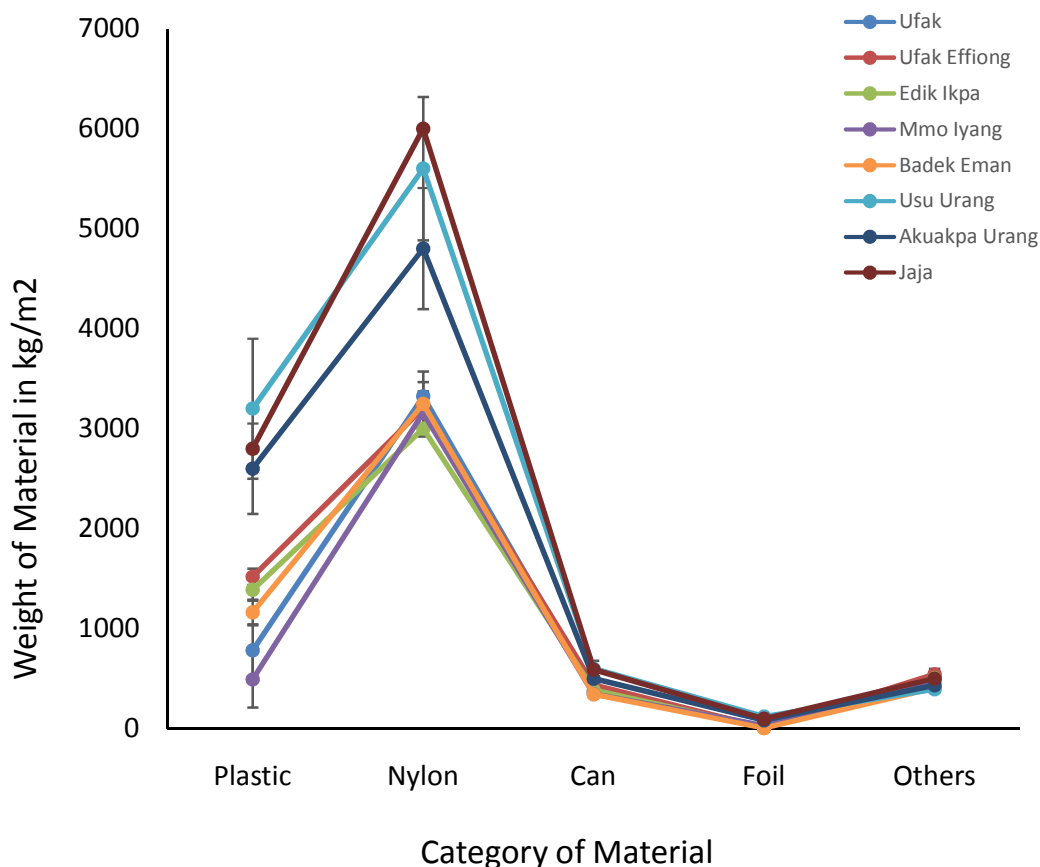
Fig. 3. Mean composition of material at different sampling locations in Akwa Ibom State (SEM =n=30)

The result of the characterization of the suspended debris in creeks in Akwa Ibom State is presented in Figs. 3 – 8 and Table 3. The categories of debris comprised plastic, nylon, can, foil and others. Others was made up of mainly nypa palm and unidentified objects. Nylon recorded the highest amount in composition followed by plastic, can, others and foil recorded the least value across all locations Fig. 3. Average weight of suspended material per square meter and per square kilometer is presented in Table 3. It ranged from the least value of 4,511 kg/m² at Akpam Nfrugam to the highest value of 9,991 kg/m² at Jaja creek. This translates to a least value of 90,220 kg/km² at Akpam Nfrugam and the highest value of 199,820 kg/km² at Jaja creek. Based on 20 tons

The quality and severity of the distribution of suspended debris in Akwa Ibom State is presented in Figs. 3-8. Plastic ranged from 1000 kg/m² to 1,400 kg/m² at hotspots such as Jaja, Usu Urang, Akuakpa Urang creeks Figs. 3 and 5. The category 'others' ranged from 312 kg/m² to 567 kg/m² Fig. 6 and the hotspots were at Ediki Ikpa and Ufak Effiong. Nylon ranged from 2,850 kg/m² to 3,419 kg/m² and its hotspots were at Usu Urang, Akuakpa Urang and Ediki Ikpa Fig. 7. Foil material ranged from 2 kg/m² to 5 kg/m² and recorded its hotspots at Usu Urang, Akuakpa Urang, Ediki Ikpa and Ufak Effiong Fig. 7. The distribution of can material ranged from over 250 kg/m² to 440 kg/m² with hotspots in ikot Ibriton, Jaja, Ediki Ikpa and Ufak Effiong creeks Fig. 8.
